# Experience from a thermodynamic efficiency test introducing generator cooling water back into the main discharge

E. Nilsen<sup>1</sup>, H. Hulaas<sup>2</sup>

<sup>1</sup>Norconsult AS, erik.nilsen@norconsult.com, Sandvika, Norway

## Abstract

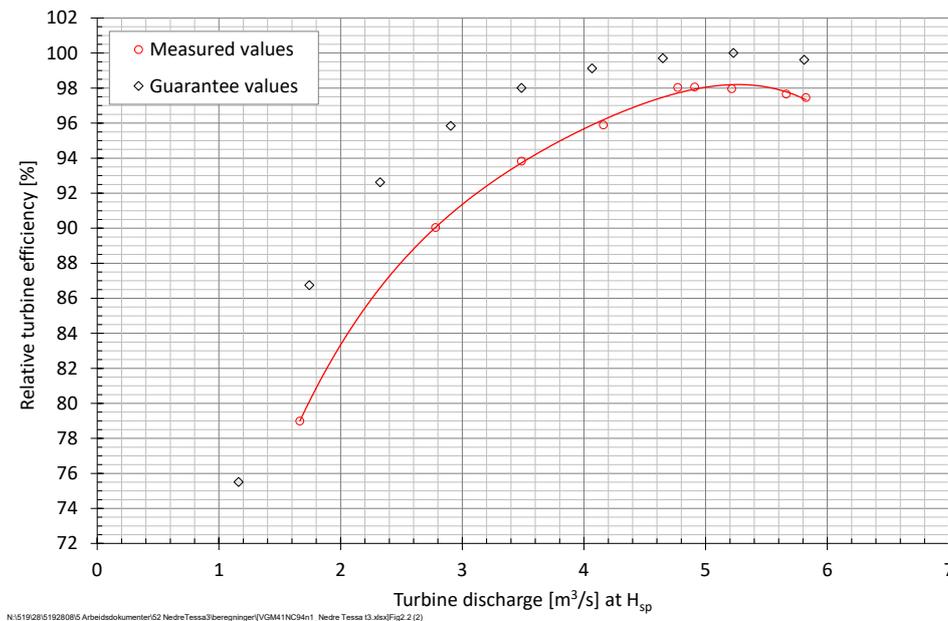
**Figure 1** Initial test results compared to guarantee values

To verify the turbine efficiency and the turbine output guarantees after an upgrade of a small vertical Francis unit (300 m, 16 MW), a thermodynamic efficiency test according to the IEC 60041 [1] was performed. The measured turbine efficiency was however surprisingly low; well below the guarantee data given by the Contractor; see Figure 1.

The efficiency shortage was later established due to cooling water from the generator coolers and the generator bearings being led back to the main discharge at the start of the draft tube bend upstream of the low pressure measuring section.

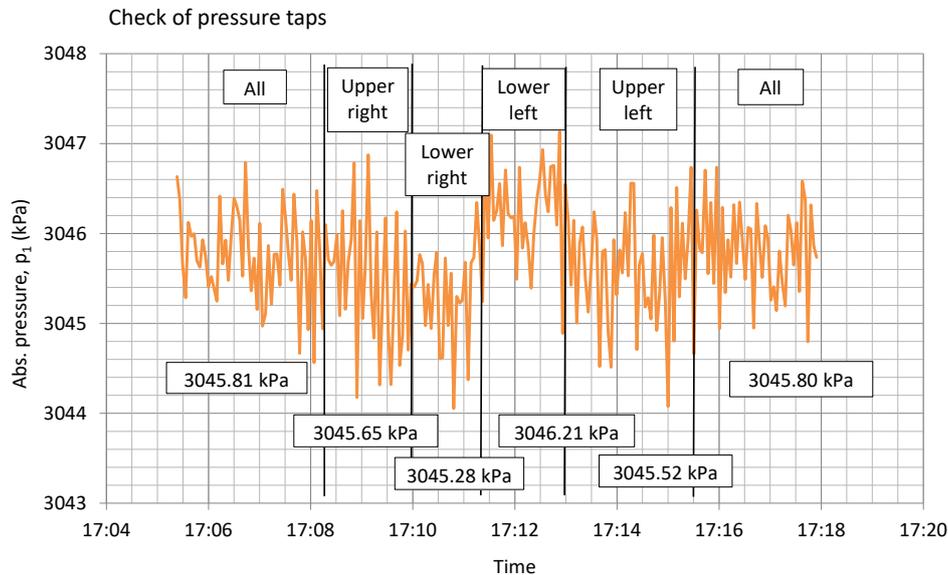
**Figure 2** Checking of pressure taps at high pressure measuring section

At steady state the pressure fluctuations were small. For checking the pressure taps (4 four taps connected through a ring manifold), each tap was read individually (IEC 60041 chapter 11.4.2). The readings from the test are shown in Figure 2. The difference in the pressure readings is quite small and well within the requirements given by the IEC 60041, see Table 1. The quality of the pressure taps is therefore assessed as good.

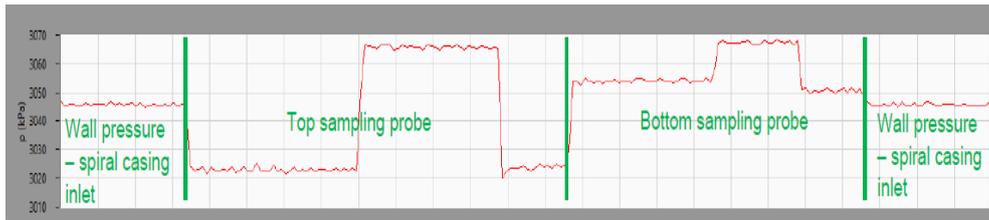
**Figure 3** Check of sampling probes; pressure recordings

During the test it was observed that the sampling probe pressures differed from each other. The difference also varied throughout the test. Sometimes the sampling probe pressure could even go below the wall pressure. This pressure variation was due to the water quality (organic waste such as leaves, humus etc.) effecting the sample flow rate/pressure tap of the sampling probe. To check the sampling probes, the sampling flow was shut off and the stagnation pressure was measured. The recorded pressures are given in Figure 3. The check is summarized in Table 2. The test does not identify any faults. The stagnation pressure is nearly equal for the two sampling probes and higher than the wall pressure.

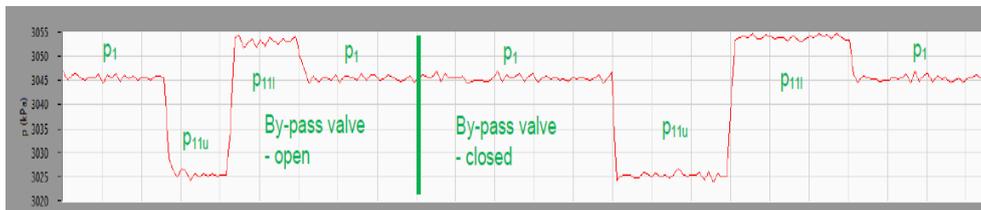
**Figure 4** Check of sampling probes; pressure recordings when operating MIV by-pass valve

During normal operation the MIV by-pass valve is open. To check if this condition interferes with the recordings from the high pressure measuring section, the by-pass valve was shut. The recorded pressures are given in Figure 4. No significant changes in the recorded values were detected. The by-pass valve being open has therefore no effect on the measurements.

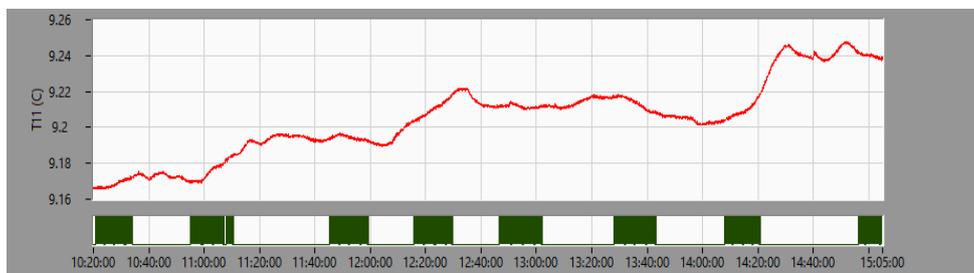
**Figure 5** Temperature variation throughout the day at high pressure measuring section

The water temperature at the turbine inlet did however vary some throughout the day. Both positive and negative gradients were observed, see Figure 5. The temperature gradients were however quite small, no greater than 1 mK/min, during the test runs and therefore well within the limit of 5 mK/min (IEC 60041 chapter 14.6.1). The observed temperature variation was expected (a characteristic for this power plant), the power plant utilizing water from a small intake dam.

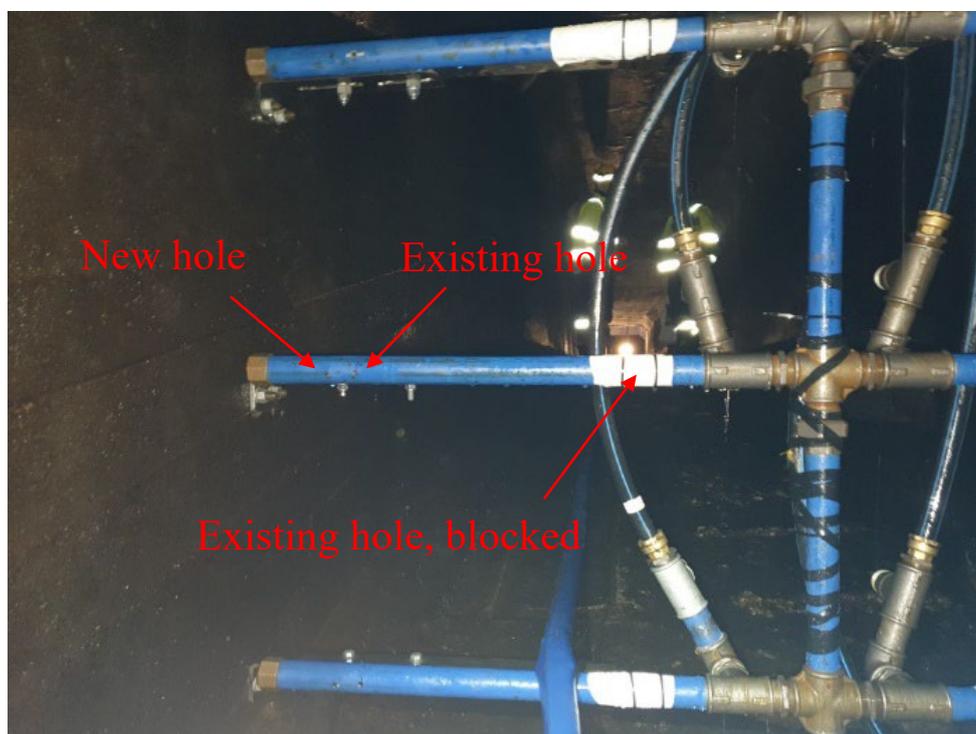
**Figure 6** Tapping holes configuration sampling frame low pressure measuring section

To check if the position of the sampling frame tapping holes was significant, the tapping hole configuration was changed as shown in Figure 6. The original design was used during test no. 311-318. For test no. 319-323 the hole closest to the centre was blocked and an additional hole was drilled nearer to the draft tube wall. No major changes to the temperature registrations were recorded.

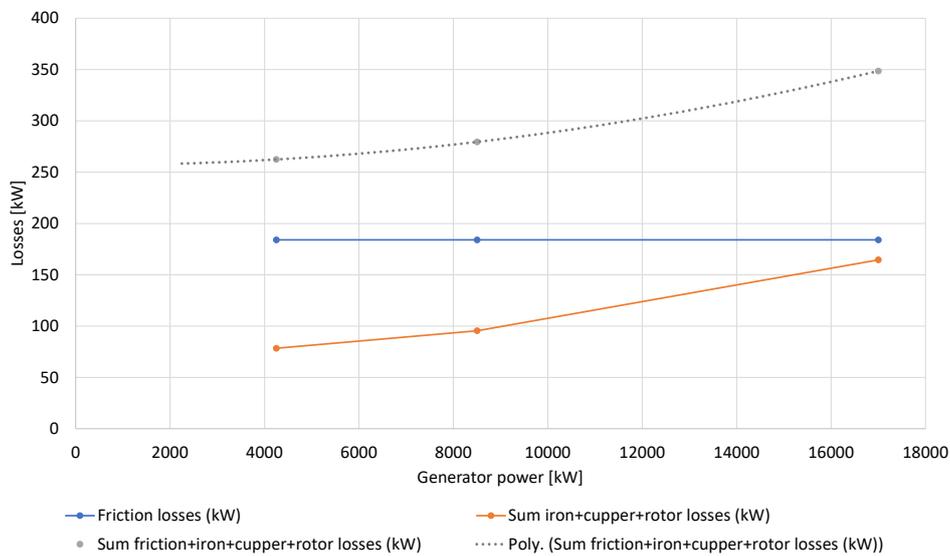
**Figure 7** Generator losses as a function of generator output

Based on the data given in Appendix 3, a correction curve for  $P_{Losses}$  was made (see Figure 7). The bearings represent a constant loss (friction). The iron losses, the copper losses and the rotor losses will be transferred through the generator coolers.

Knowing the generator losses (established at the FAT, see Appendix 3 for values), it was possible to correct the measurements for the amount of energy added to give the true turbine efficiency. The corrections were made according to IEC 60041 Appendix H.2 Adding a discharge  $q$  (see Equation (1)).

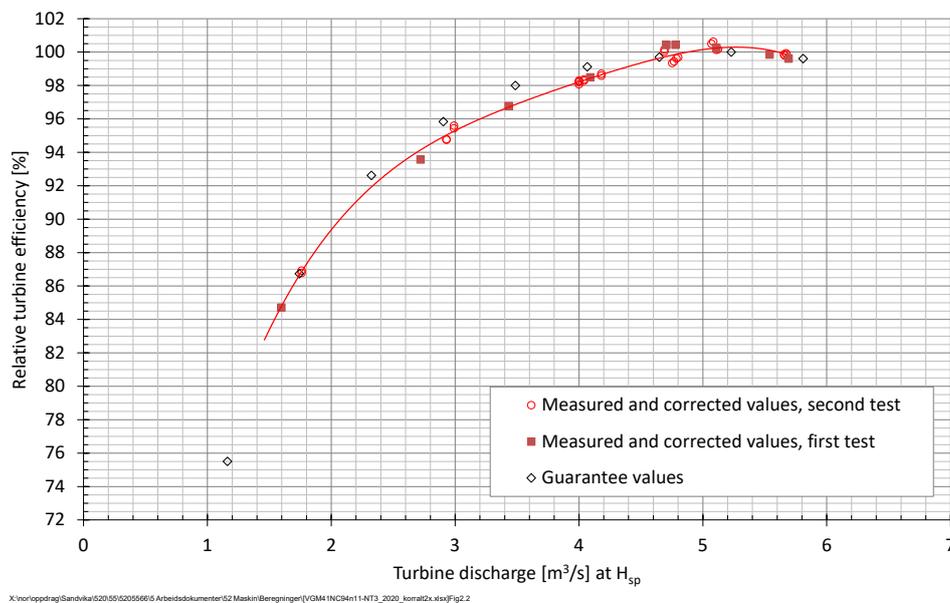
**Figure 8** Turbine efficiency, final test results

Correcting the measurements according to the procedure described in chapter 4, the final test results become as shown in Figure 8. The diagram also includes the test results from the first test also corrected according to the same procedure.

The corrections made are transposing the turbine efficiency back to expected level, and the turbine efficiency could finally be accepted. It also worth noticing that the first measurement using a collecting sampling frame repeats the second measurement using individual temperature recording even though the measuring conditions are unfavourable.
