Onsite calibration of flow meters by ATT reference with wetted transducers

Heming Hu¹, Hang Cui¹, Zhuo Yang², Peter Gruber³

Abstract

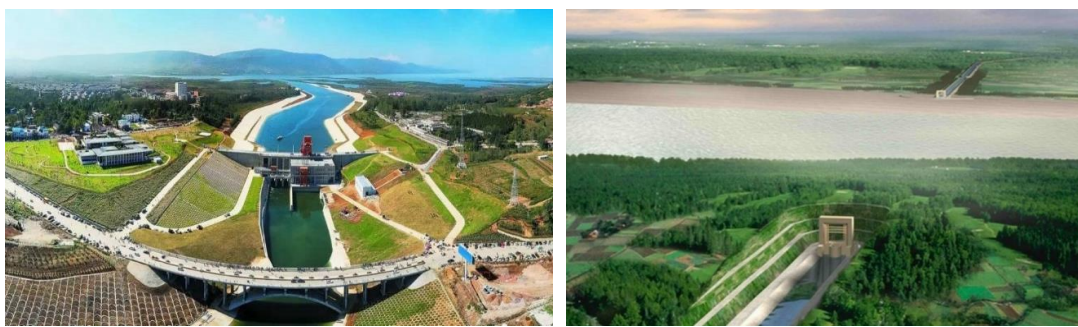
Fig. 1: Central route of South-to-North Water Transfer Project

(a) headwork project

(b) Yellow river crossing project

The South-to-North Water Diversion Project is a multi-decade infrastructure mega-project in China. Ultimately it aims to channel 44.8 billion cubic meters of fresh water annually from the Yangtze River in southern China to the more arid and industrialized north through three canal systems. The central route runs from Danjiangkou Reservoir on the Han River, a tributary of the Yangtze River, to Beijing and Tianjin. This project involved raising the height of the Danjiangkou dam by increasing the dam crest elevation from 162 m to 176.6 m above the sea level. And this allowed the flow into the water diversion canal to begin "downhill", pulled by gravity, to the lower elevation of the canals, without the need for pump stations. The whole project was completed around 2014. Fig. 1 shows the headwork project and Yellow river crossing project separately.

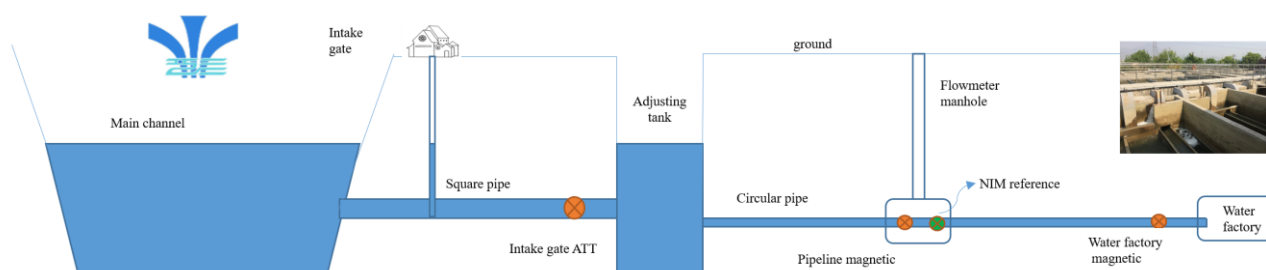
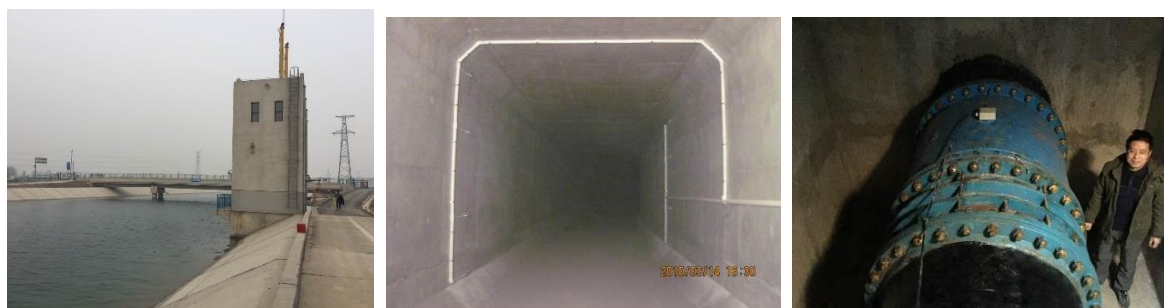
Fig. 2: Flow measurement for a typical water delivery branch line

(a) Flowmeters in series for delivery branch line

(b) main channel (c) intake gate flowmeter (d) local branch flowmeters

There are many flowmeters installed for the South-to-North project. They belong to three different parties including the main line company (water seller), the local branch company (water delivery) and the water factory who will do the water treatment and supply water for every terminal user. A typical arrangement is shown in Fig. 2. From the main channel to the right a closed fully filled pipe (often a square shaped channel Fig. 2c)) takes water out perpendicular to the canal flow direction to the intermediate water tank. From there, water is pumped or flow by gravity in circular pipes (Fig 2d)) via the water delivery company to the water factory to the right in the picture. Flow meters are installed at different locations indicated by oval red signs with a cross. The diversion gate flow meter in the square shaped channel from the main canal to the water tank, is usually a 1E2P (1 plane 2 paths) ATT flow meter, while the others are either MID or ATT flow meter. The main line company installed more than 200 ATT flow meters. The main channel has intake gate facility which can control flow rate and water level theoretically. In practice, the flow control is usually done by the pump station or the water factory. The water velocity in the square shaped channels is very low, from 0.1m/s up to 1m/s, and it is one of the difficulties of an accurate flow measurement there.

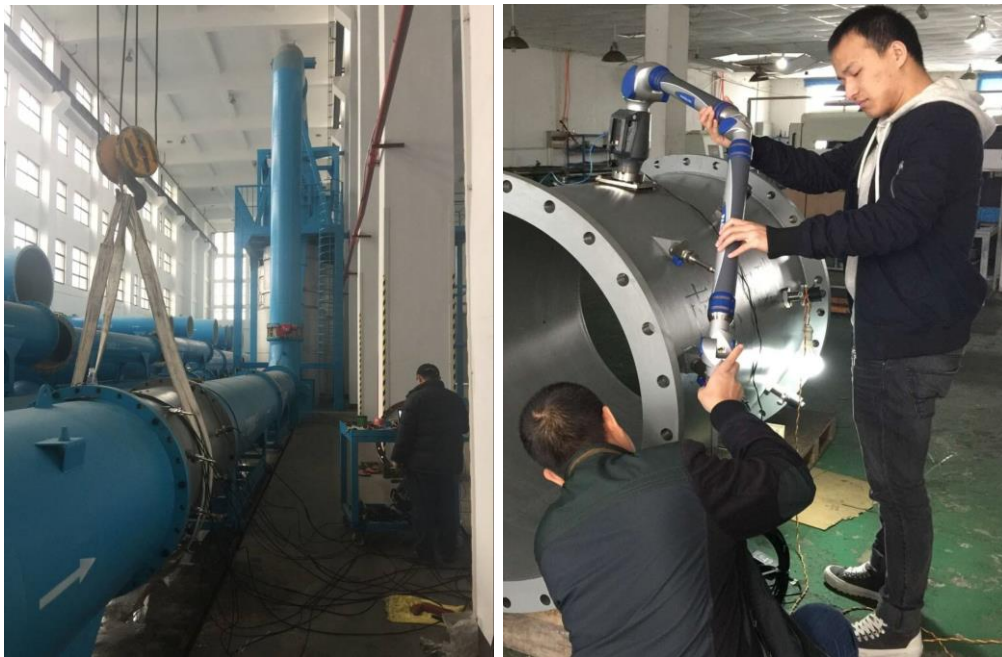
(a) large-diameter flowrate standard facility (b) geometrical measurement using FARO arm
Fig. 3: photos of laboratory test

The reference ATT flow meter of NIM is a 8 path meter in 2 crossed planes. The uncertainty of the ATT method used for large pipe flow measurement stems mainly from the fact, that there is: 1) not a high enough precision of the transit time measurement, and uncorrected zero point especially for low velocity measurement; 2) not an accurate enough geometric parameter measurement; 3) a flow field influence related to transducer protrusion / recession and not enough upstream / downstream straight pipe length. To provide an accurate reference flow rate value, all above three points have to be dealt with carefully. A FARO arm (Figure 3b) was used to get accurate geometric parameters, several experiments were carried out to test the transducer protrusion effect using a gravimetric flow rate facility (Figure 3a).

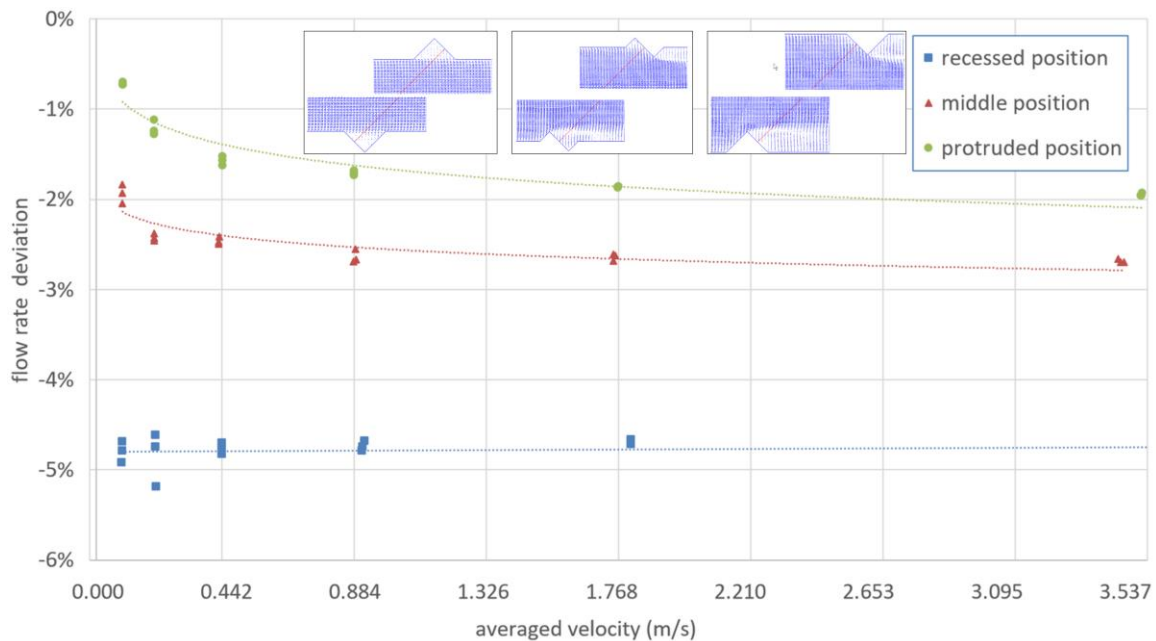
Fig. 4: flowrate bias at different probe installation positions (DN400)

The gravimetric method is used to get a reference flow rate, and the NIM ATT flow meter with a DN400 pipe is tested at three different transducer positions. Figure 4 shows the differences of flow rate deviation at the three positions. It is clear that the recessed position can provide a stable flow rate without influence of the velocity. So it was decided to use the recessed positions as the best choice for the onsite installation positions of the transducers.

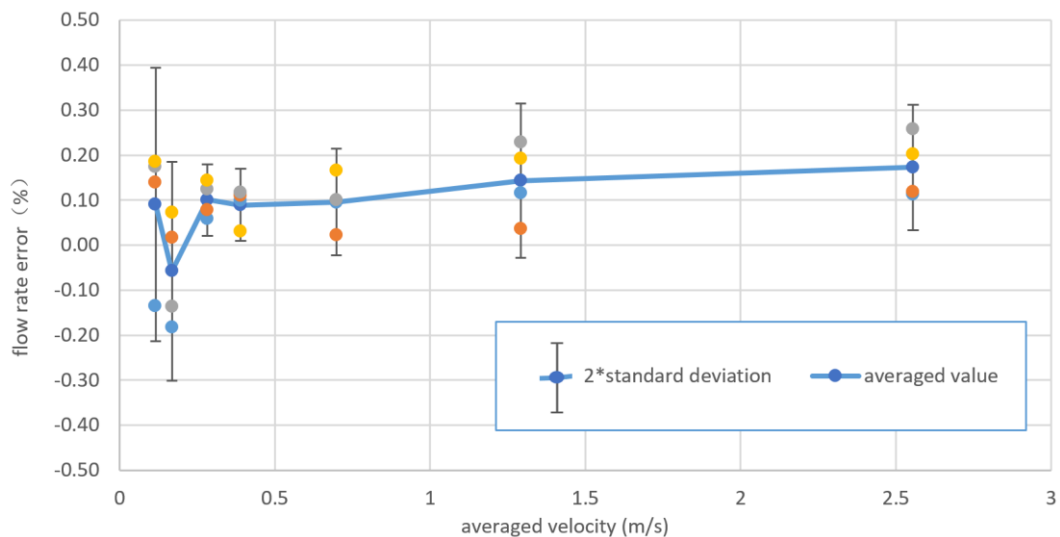
Fig 5: flowrate error after correction (DN1000)

To get an accurate correction factor for larger pipe, an experiment was conducted for a DN1000 pipe using the same gravimetric facility. The result shows a stable bias of negative 1.6%. After the implementation of a correction factor of 1.016, the flow rate error of this DN1000 flow meter is in Figure 5. There are four circles for each velocity step, and we calculate the standard deviation for each step. They are all smaller than 0.5%. We will use this corrector factor for the onsite flow calibration because they have the similar pipe diameter.

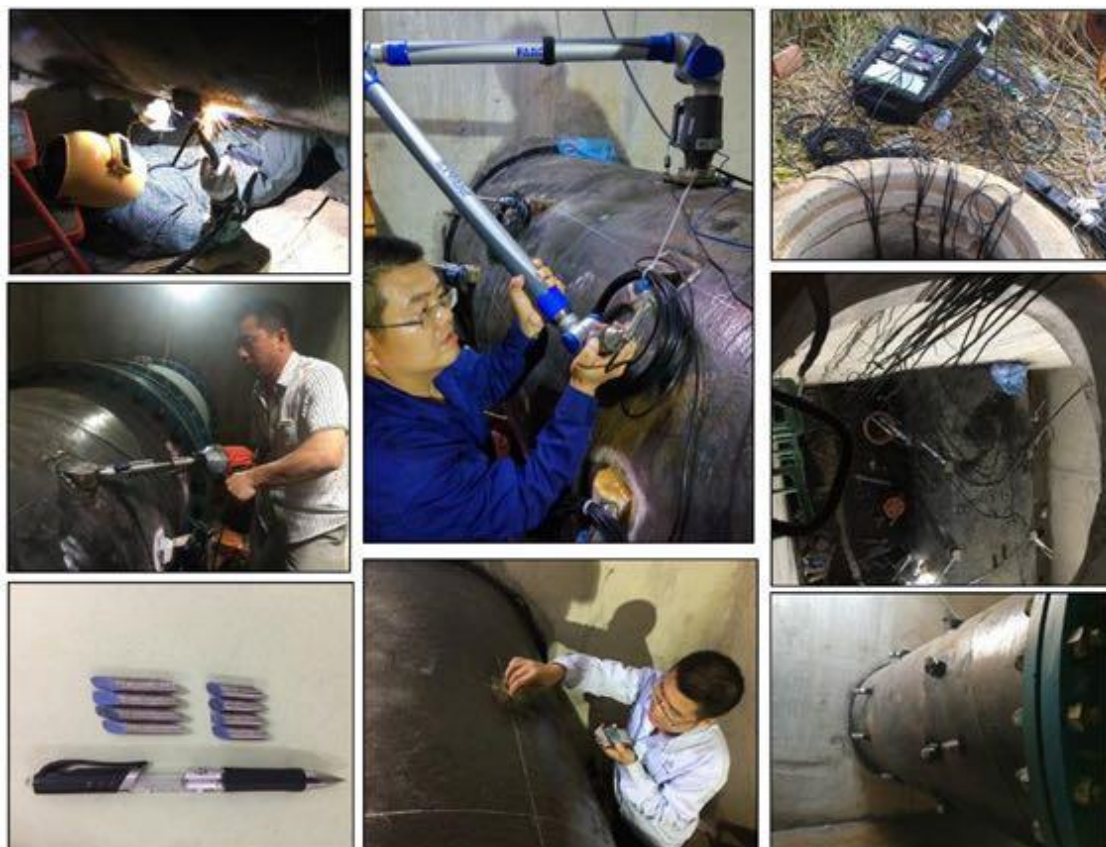
Fig 6: Field work procedure (orientation / alignment / drilling with flow)

After the calibration of the flowmeter in the laboratory, the transducers used in the calibration are removed and taken together with the signal processing unit to the field site. At the site, the positions of the transducers are marked first with the help of strip cloth and a tape measure. Then the holes are drilled under filled pipe conditions, where it must be noted that the water pressure is not very high. A kind of valve mechanism prevents the water to leak through the hole while drilling. After the drilling is completed, the transducers are inserted in the prepared holes. The exact positions of the transducer pills are then measured again by the FARO arm, and also the outer pipe points which are used to fit a cylinder. The thickness of the pipe can be measured point by point by an ultrasonic thickness gauge. With all this information, all the geometric parameters needed can precisely calculated, including path lengths, path angles, path heights and also the inner diameter of the pipe. Then the transducers can be connected to the signal processing unit, and from the transit times of every path, a reference value of the current flow rate in the pipe is obtained. Figure 6 shows the procedures in pictures.

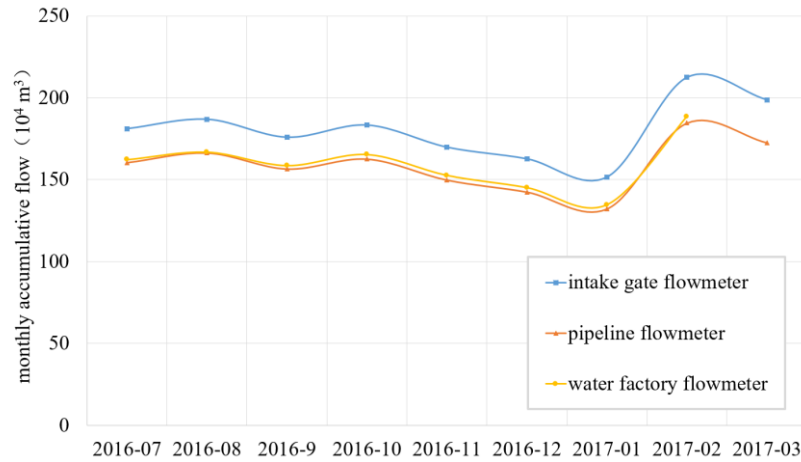
Fig. 7: monthly accumulative flow

The first case considers a delivery branch similar to the one shown in Figure 2: a square fully filled channel equipped with ATT 2-path in one plane flow meter of the water seller (intake gate), followed by an MID flow meter of the water delivery company after the tank (pipeline) and finally another MID flow meter of the water factory. Historical data of the flow readings of all instruments were available at a monthly rate (see Figure 7).

It can be seen, that the ATT meter at the intake gate has a deviation of around 20% compared to the other two MID meters. The parties involved in the billing of the water quantities were not satisfied with his situations and asked therefore a third party (NIM) to carry out a reference measurement. The regular flow rate is about 0.7 m³/s, so the flow velocity is 0.35 m/s in the square pipe with a dimension of 1.4m*1.4m and 0.62 m/s in the circular pipe with a diameter of 1.2 m. low velocity should be one of the reasons for bad performance of the three flowmeters.

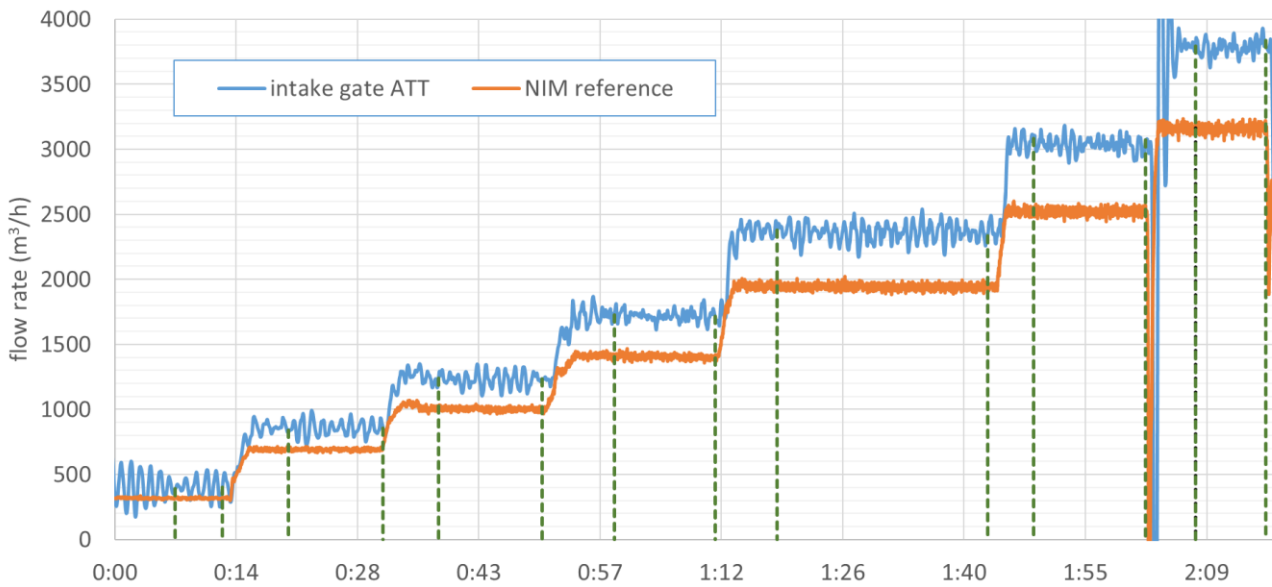
Fig. 8: flow rate time-series of onsite calibration

With the reference meter in place and correctly parameterized, a series of operating points were set with increasing flow rate as can be seen in Figure 8. All the flow rates were kept constant for about 15min with the exception of one. The flow varied between 300 and 3200m³/h in steps of ~500 m³/h. The flow rate data between each pair of dotted vertical lines will be used to calculate averaged flowrate and its standard deviation for each step. The intake gate ATT in square pipe shows much larger oscillation than the NIM reference in the circular pipe. The reason may be the small change of water level in balance tank which connects the square pipe and circular pipe. From Figure 8 it can be concluded, that the installed ATT flow meter of the water seller is constantly above the reference ATT meter by about 20% with a small decrease with increasing velocity.

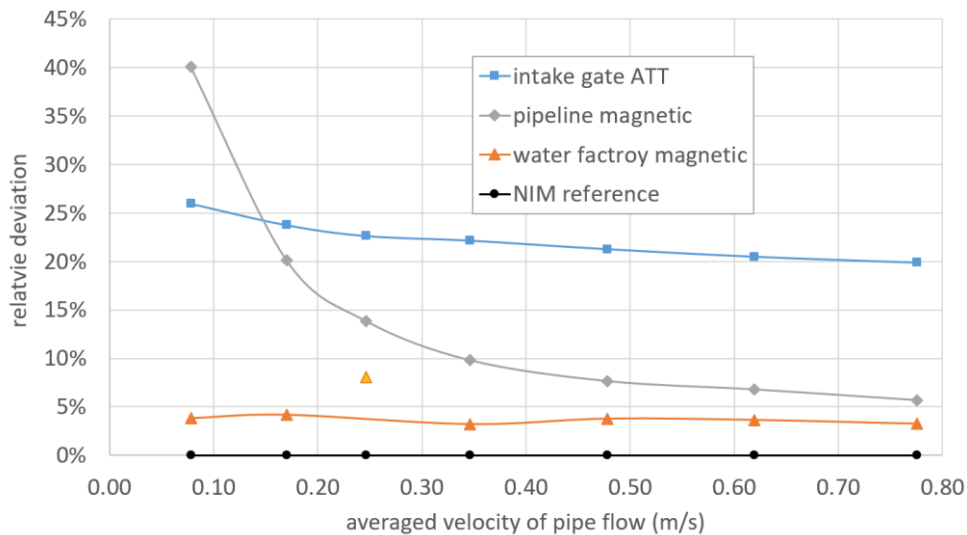
Fig. 9: flowrate comparison with NIM ATT as reference

Figure 9 shows the relative deviations in % of the three installed flow meters, the ATT meter of the installer and the two magnetic flow meters with respect to the NIM reference. It is interesting to note that one magnetic flow meter has nearly a constant deviation of about 4% over the whole range, while the other magnetic flow meter has a typical decaying trend of $1/\text{velocity}$, starting with a very high value of +40% and then going down towards the first magnetic flow meter. The two magnetic meters are from different companies. The discrepancy of this behavior is not yet clear. The ATT flow meter performs better than one of the two magnetic flow meters for small velocities, while for higher velocities the deviations are much higher (~20%) than the reference value. This behavior cannot fully be explained at the moment and must be investigated further. Non optimal parametrization of the flow meter is one of the possible reason.

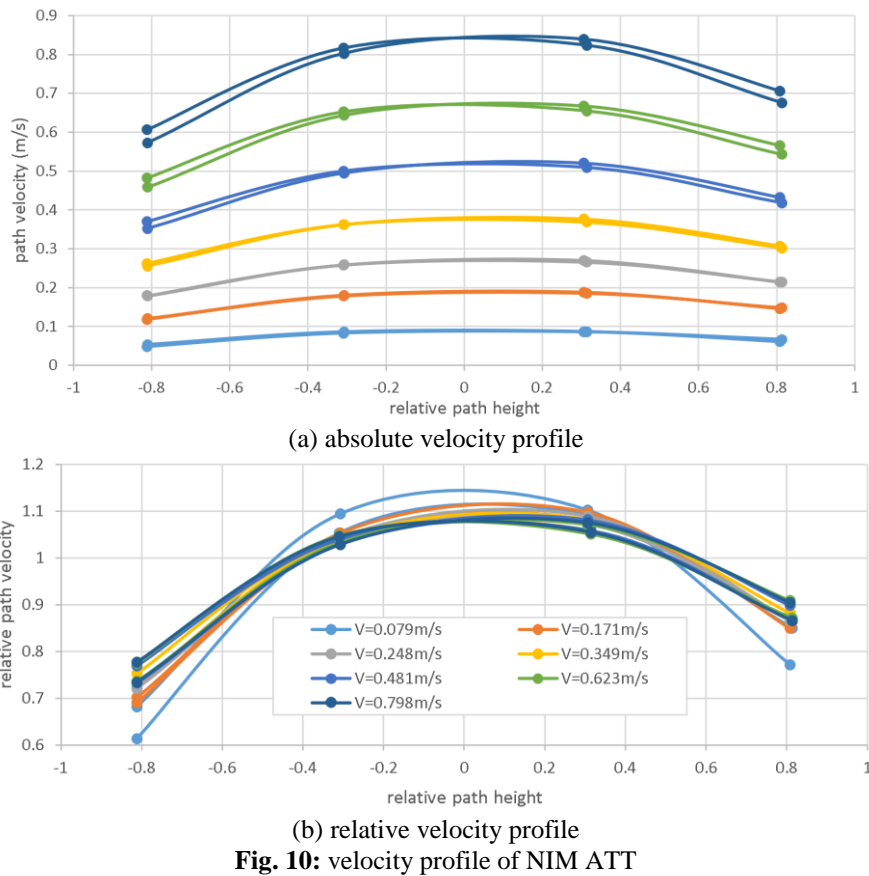
Figure 10a & 10b show the velocity distribution obtained by the NIM ATT reference flow meter for the different velocities. In Fig. 10a the individual path velocities (totally 8) are shown, indicating small cross flow components for the higher velocities while in Figure 10b the averaged layer velocities (totally 4) are displayed in a relative way normalized with the average velocity. The relative flow profile changes a little for the condition of the lowest velocity.

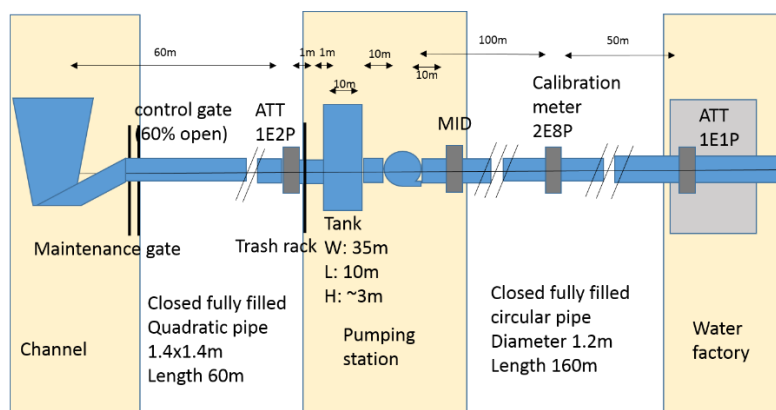
Fig. 11: flow meter installation sketch diagram, side view

The second case deals with a similar situation as the first one. The difference from the flow measuring point of view is the 1E1P ATT flow meter of the water factory. The detailed installation is shown in Figure 11. From the main canal the delivery branch square shaped channel leads to the water tank. At the entrance to the delivery channel there are a maintenance gate and a control gate, which is in normal operation at 60% open. Before the water enters the water tank there is a trash rack, which has additionally a fine mesh reducing sand deposits in the tank (see Figure 12). The deposits stick however to the mesh and get also deposited near the trash rack. The trash rack itself is located only a short distance down-stream of the 1E2P ATT flow meter. The locations of the MID, the reference flow meter of NIM and the 1E1P ATT meter can be read out from Figure 11. All three meters are downstream of the tank, while the ATT 1E2P meter is upstream of the tank. The influence of the tank is considered to be small, as in steady state the height of canal and tank are nearly identical. Unfortunately, the water level measurement of tank and canal were not available at the time of the investigation. The velocity covers a small range of values from around 0.15m/s to 0.35m/s, that means really small flow rates. The pump station was put into operation in 2016 and in 2017 complaints from the companies were reported that the meters are drifting away, especially the 1E2P ATT flow meter.

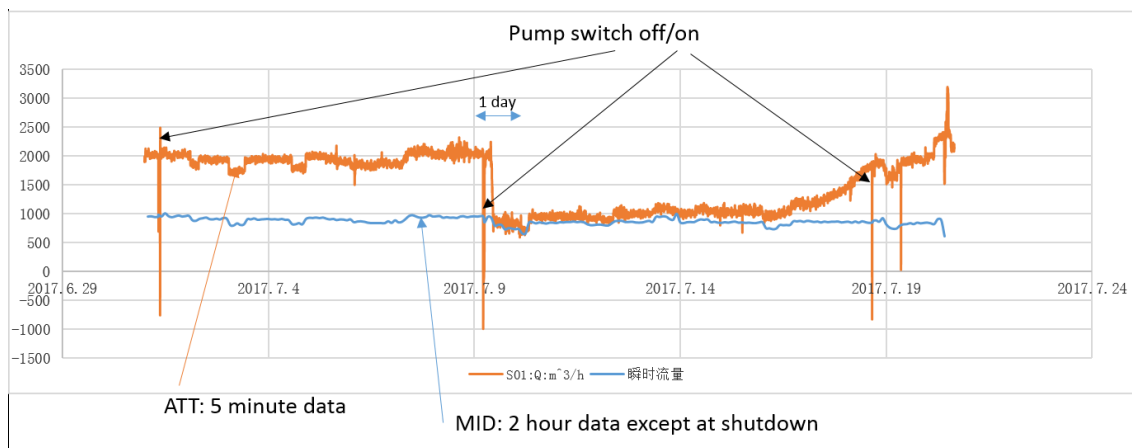
Fig. 13: historical flow rate before and after deposit cleaning

NIM carried out to measurement series, one on May 25th 2017 and the other one on July 20th 2017, where the flow was varied. Figure 13 shows the historical flow rates of the 1E2P ATT meter and the MID between these two dates, showing large discrepancies up to a factor 2. The MID was more or less stable while the ATT meter varied in a wide band. On July 9th, that means in between the two NIM measurement campaigns, the trash rack, the mesh and part of the channel close to the ATT meter were cleaned by a diver. After starting the pump again, the two flow meters have only a small deviations in their flow rate values, which indicates strongly that the cleaning had a large effect on the ATT measurement close to the trash rack and mesh. After the cleaning, the ATT meter was stable for about one week before it started to drift away again. At the time of the second reference measurement series, the flow was even higher off against the MID than at the first measurement series in May.

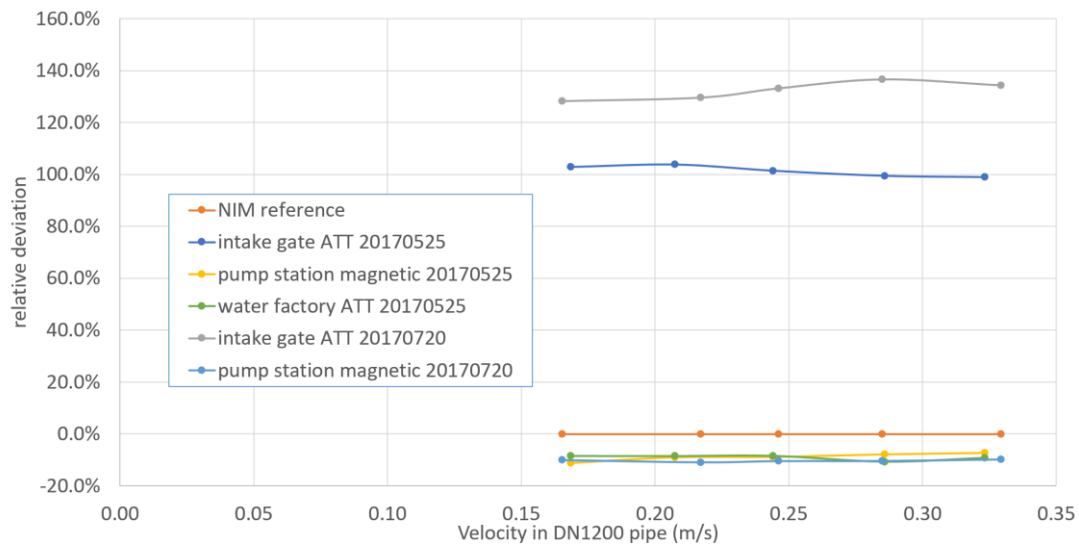
Figure 14: flow rate comparison before and after deposit cleaning

Figure 14 shows the readings of all four flow meters for the measurements in May and 3 readings (reference, 1E2P ATT and MID) for the July measurements. The deviations in % are displayed with the reference meter as the zero line. The figure shows some interesting findings:

- The 1E2P ATT flow meter at the inlet to the tank shows for both measurement campaigns (May 25th and July 20th) very large deviations of over 100%. As mentioned before, in between these two dates the meter showed readings which were very close to the reference (~2-3%), after the cleaning.
- The other flow meters are all very close together, but their readings are ~10% under the reference values of the NIM meter.

- The installation location of the 1E2P ATT meter is not correct. If possible, one would have to move the location at least to the middle of the delivery channel.
- If the meter cannot be moved, periodic cleaning is mandatory. Additionally some monitoring of the proper functionality of the meter should be implemented.
- For the MID and the 1E1P ATT meter the 10% offset should be analyzed in detail.
