Operating Experience from intentional transit of fine sediment through hydraulic turbines

Within the framework of securing the bottom outlet valve of the Chambon Dam (France, Romanche), EDF HYDRO succeeded in removing a volume of approximately 32,000 m³ of sediment without interrupting production while complying with environmental regulations. The solution used was to perform a sediment dilution and pumping operation along with injection at the intake and transit through the hydraulic turbines of St Guillaume II.

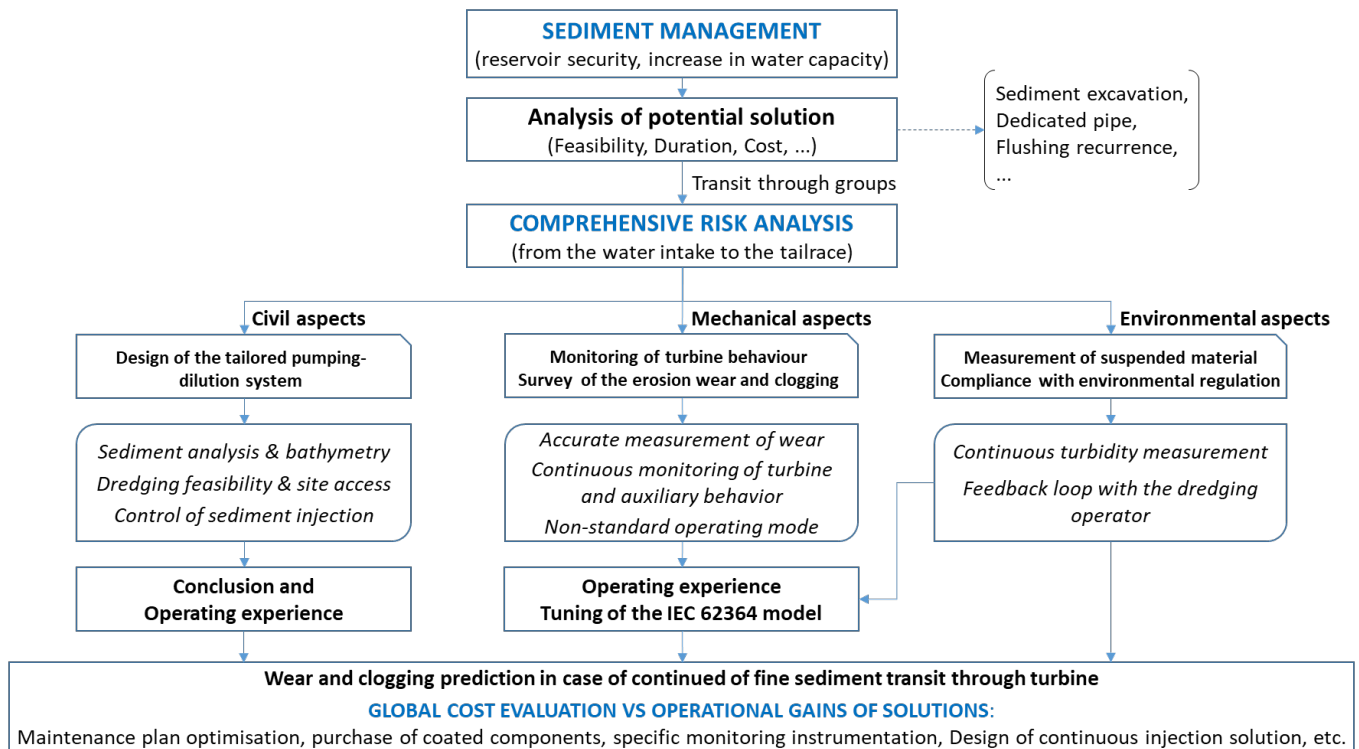
The overall process is illustrated in the following diagram:

Injecting sediment continuously through hydraulic turbines can be an advantageous solution for managing the silting-up of water reservoirs. However, before considering a sustainable operating process that aims to intentionally increase the natural concentration of sediment flowing through the turbines, many issues need to be addressed. The scope covers a wide range of engineering aspects: environmental, civil, mechanical, measurement & instrumentation and operational. To prevent a catastrophic situation where the turbines are completely eroded, some steps must be validated, requiring comprehensive risk analyses and real-time monitoring from where dredging is being carried out to the behaviour of the turbine.

Typically, these steps consist of defining and validating:

- I. The capability of the dredging operator to design an adequate pumping-dilution system which will control the sediment concentration at the injection inlet in real time. To reduce the impact of erosion wear, it is necessary (but challenging) to keep the concentration of suspended material in the turbines as constant as possible.

- II. The instrumentation system in the hydraulic circuit used to measure the concentration of sediment passing through the turbines. A feedback loop must be created to inform the dredging operator of what is happening inside the turbines (notwithstanding the time required for the sediment to travel from the water intake to the turbines).

- III. A comprehensive risk analysis related to erosion and clogging of each component in the hydraulic circuit to prevent any issues. Since each risk evaluation is site dependent, the analysis must take into account the natural transition history of the sediment (routine and extraordinary events) and the operator's feedback. The results of the analysis will be used to identify protective measures that need to be implemented.

- IV. Detailed measurement of wear on mechanical components which are exposed to the sediment. This requires assessing the condition of the component (which will be used as the reference) as closely as possible to the beginning of the test.

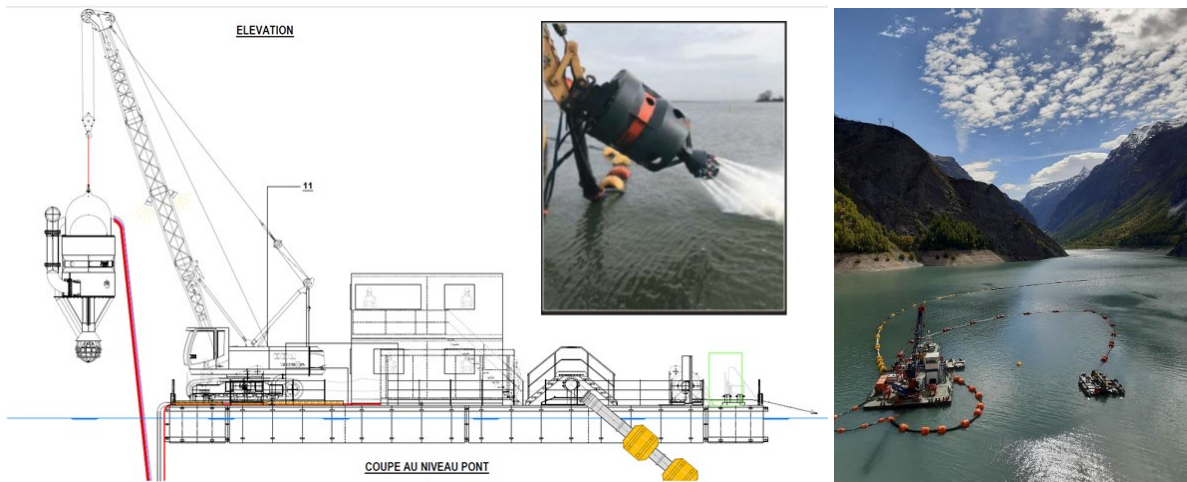
The solution proposed was based on a pendulum dredge pump operated by a crane with a double winch installed on a pontoon (Figure 1). The submerged sediment is dislodged using a pressurised water injection system (8 bar jetting) and then pumped before being released in front of the water intake.

Figure 1: Dredging station

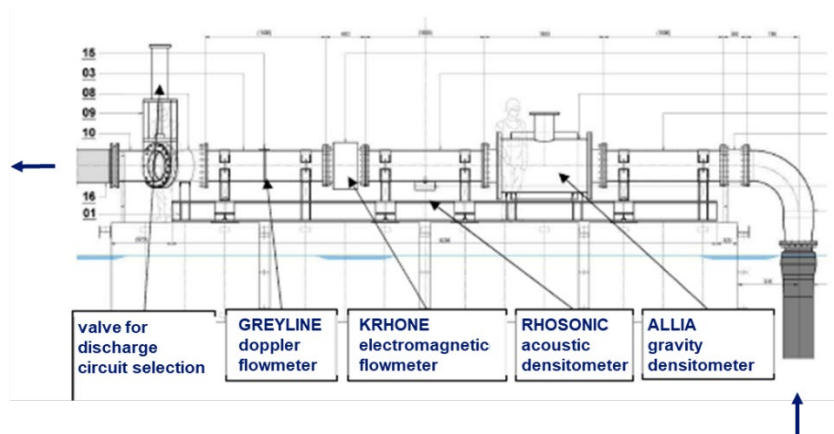
Specific monitoring of the injection process was implemented (Figure 2). This aimed to control the concentration of sediment pulp injected into the intake. This pulp is diluted with water at the water intake. Sediment concentration through the turbines was monitored in parallel (taking into account the lag for the time required for the sediment to travel from the injection port to the units). To meet a target concentration of 0.7 g/l through the units at a flow rate of 45 m³/s, the injected sediment pulp should reach a concentration of 135 g/l at a flow rate of 0.2 m³/s.

Figure 2: Instrumentation system for injected sediment pulp

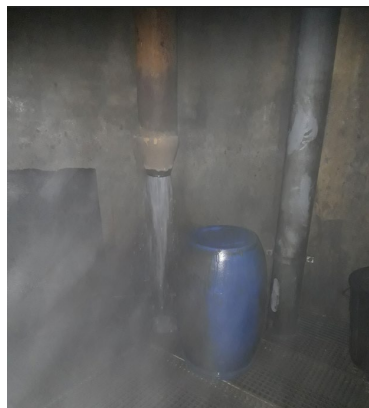
In parallel, it was decided to periodically measure the leakage at the shaft seal of both units. This was performed by the operator twice a week with a stopwatch and a 100 litre vessel (see Figure 6). The measurement was of course taken in consultation with the head of the site. Any deviations would be a basis for reviewing continuation of the operation.

Figure 6: Dewatering room conditions for shaft seal leakage measurement

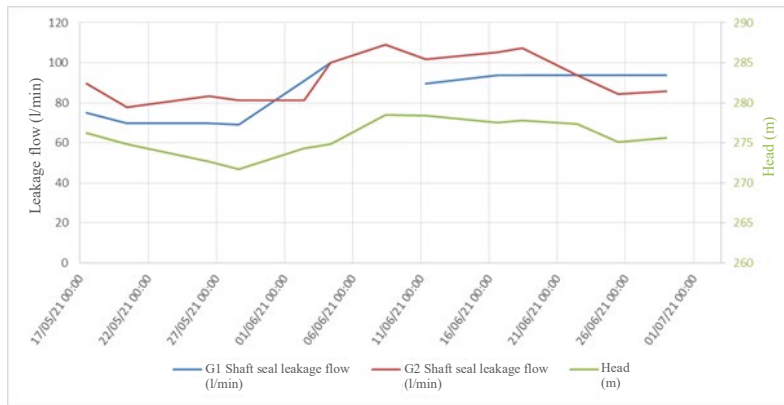
Throughout the operation no readings displayed any particular or alarming changes in any of the parameters. As shown in Figure 8, no change in the leakage (vs. head) at either shaft seal was noticed.

Figure 8: Leakage transient change at the shaft seal vs head

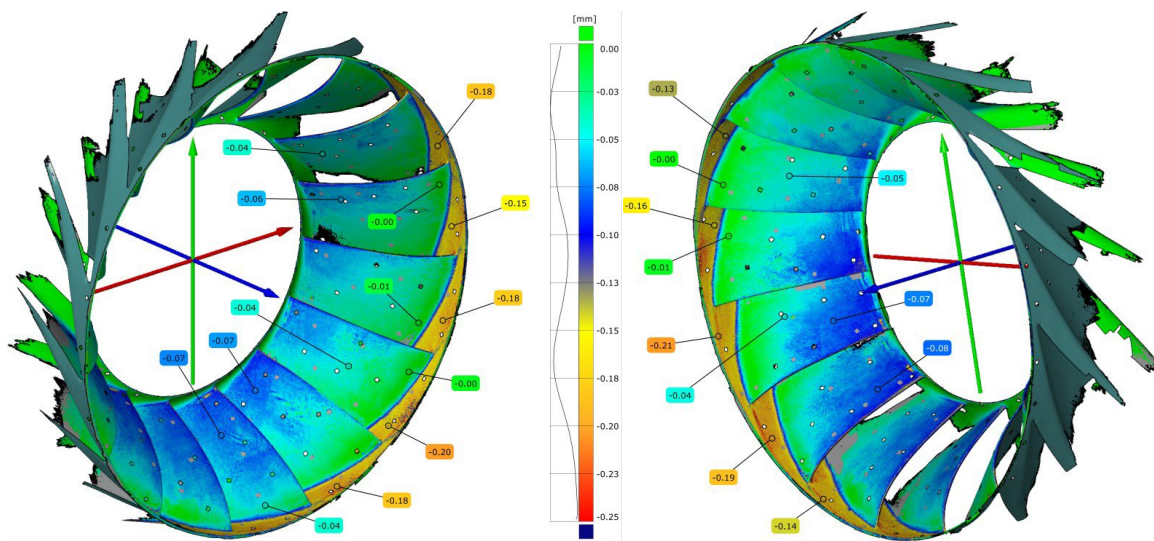
For reasons of accessibility, only the outlet of the runner was scanned. Material loss results are shown in Figure 10 for both runners (outlet side).

Figure 10: Material loss results (left: Unit #1 runner - right: Unit #2 runner)

By considering an average wear rate of between 0.18 and 0.20 mm at the runner band, the results are consistent with estimated wear rates (see orange line in Table 1).

- Wear is uniformly distributed on each blade, which confirms their physical representativeness as well as the positioning of the measurements between them.
- On both runners, measurements show similarities in terms of wear rate on the blades (almost no wear at the extrados surface apart from a few rare and faint impact marks) and in water passages (uniformly increasing wear from blade inlet to outlet).
- The order of magnitude of the maximum wear observed is between 0.15 and 0.23 mm; this is located at the runner bands.

While the trailing edges of blades appeared to have been "sharpened", they did not seem to have undergone any pronounced wear (loss of material generally less than 0.1 mm). The measured thickness of blades (at the blade outlet) remained consistent with the theoretical values given in the drawings.

Measurements of thickness losses at the runner outlet therefore confirmed the results obtained by the indirect monitoring methods: the total erosion wear measured is low.

Quantification of material loss in the runner corroborates these results. Low erosion wear (< 0.25 mm) was measured on the runner band. Other areas (guide vanes, wear plates, runner inlet and labyrinth seals) were not accessible. Therefore, they could not be measured. However, the estimated wear is sufficiently low so as not to be a cause for concern.
