SMART REHABILITATION PROJECT OF 7 SMALL HPP'S

INTRODUCTION

1. PERFORMANCE TESTS BEFORE REHABILITATION.

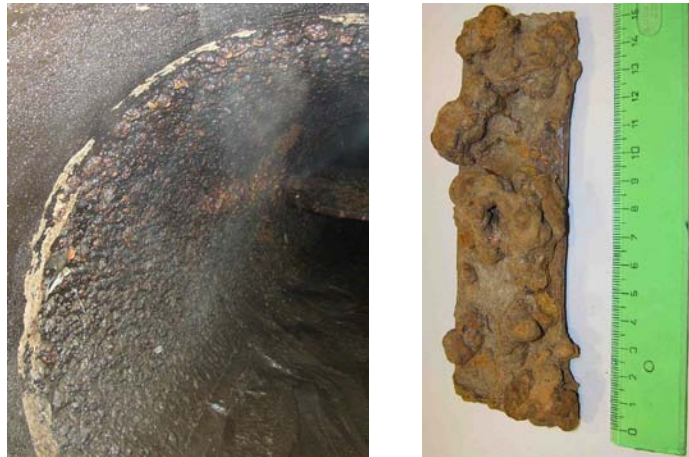
HPP Sapuncica is equipped with 2 Pelton turbines and long penstock (about 2 km) with small diameter (500 ÷ 600 mm). After 50 years of operation large-scale incrustation developed on the inside surface of whole penstock.

Fig. 1 – Penstock inside incrustation

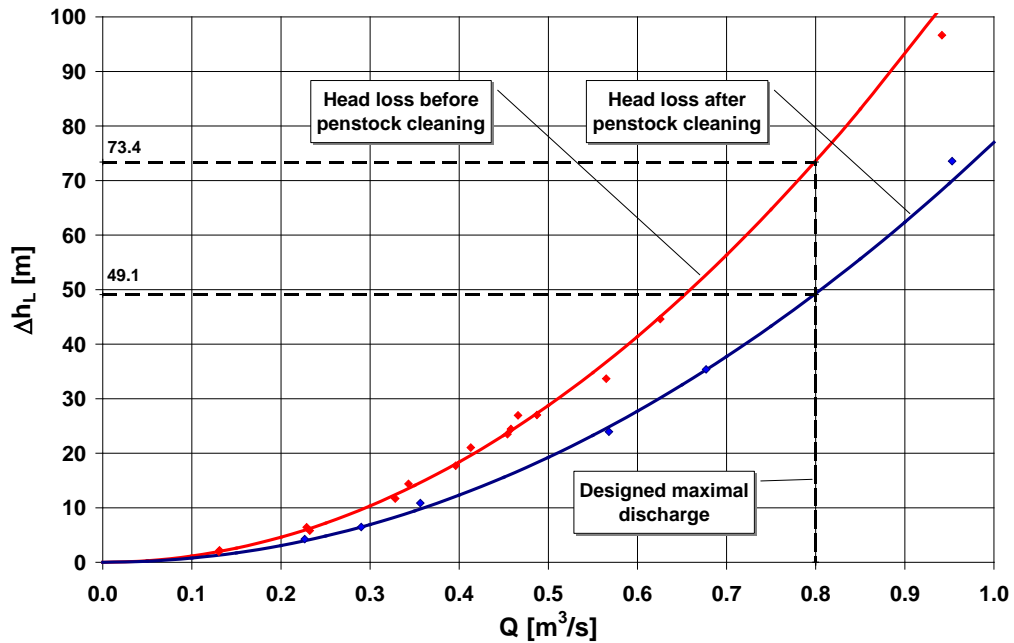
Fig. 2 – Head losses before and after penstock cleaning

The friction losses were determined by measurement, where discharge was measured by Gibson method – see *Fig. 2*. Because head loss for designed maximal discharge reached about 20% of geodetic head, the special cleaning of penstock was implemented. New measurement was arranged after cleaning. Its results are also presented in *Fig. 2*. Losses after cleaning correspond very well with theoretical calculation and they were used as basic data for design of new Pelton turbine runners. During this measurement turbine efficiency for future comparison with efficiency of upgraded units were also determined.

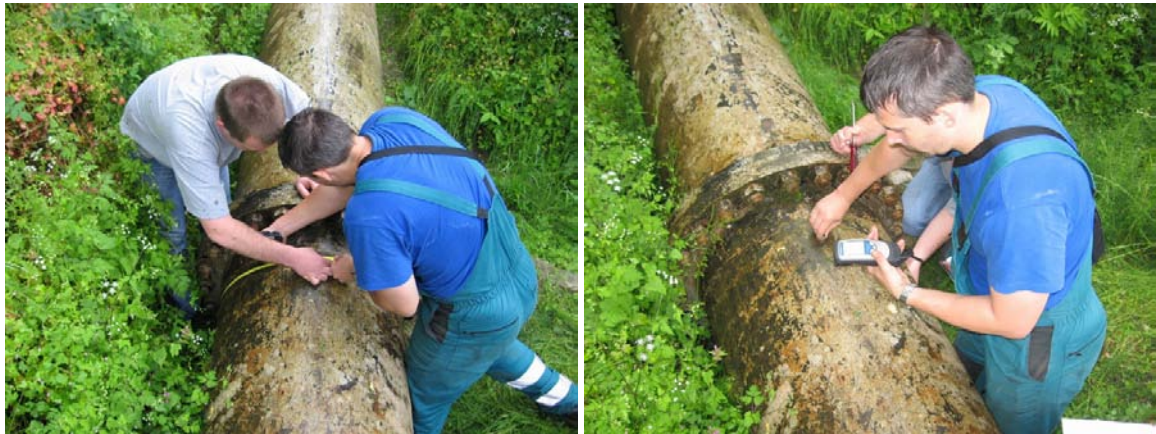
One important experience was obtained during our activities at HPP Pesočani: The overhead penstock is very good accessible, but for performance tests before rehabilitation the penstock factor was based on documentation provided by investor without its verification on the spot. The reason was time and cost minimization. The commissioning dimension measurement was carried out only before acceptance tests of new turbines – see *Fig. 5*. Length of constituent sections, outer circumference and wall thickness were exactly determined. Especially difference of penstock length comparing with provided data was discovered.

Fig. 5 – Penstock outer circumference and wall thickness measurement
